LEAD-BASED PAINT PRESENT

Enclosed you will find the results of the Lead-Based Paint Inspection (utilizing an X-Ray Fluorescence Device) which was performed at the address mentioned above on Thursday, June 4, 2009. This inspection was targeted at the painted surfaces throughout the apartment.

Project #: 09-4289

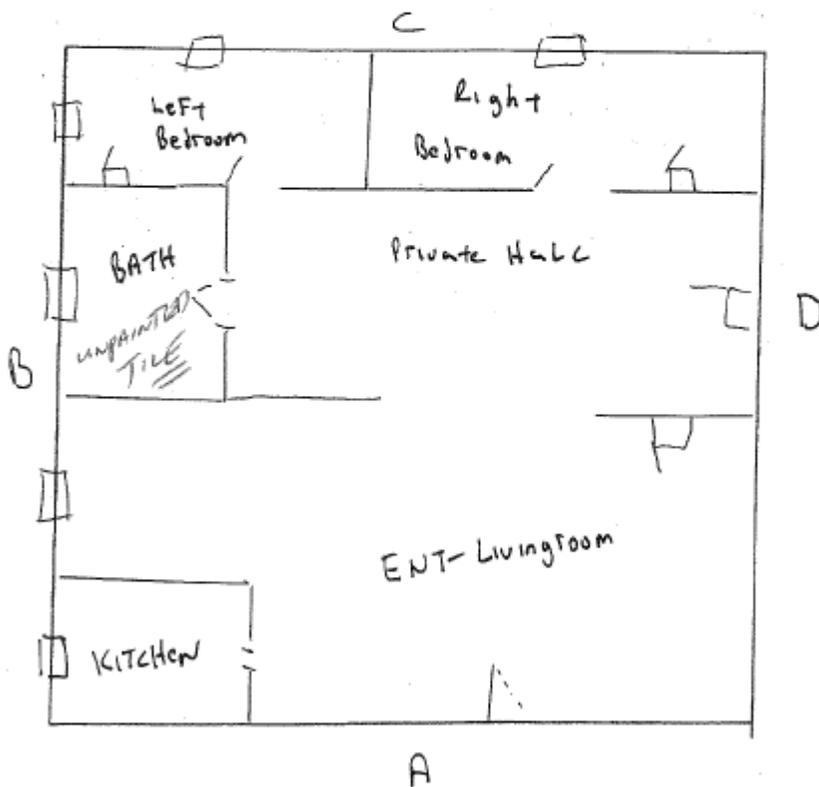
Floor Plan

A floor plan is included with this report. In each room or area, side A is always the same wall as

the apartment entry, with sides B, C, and D following in a clockwise direction. The sides are noted on the floor plan and in the Data Charts.
