# PROFESSIONAL BUILDING INSPECTORS

January 18, 2009.

## SUMMARY OF OUR FINDINGS

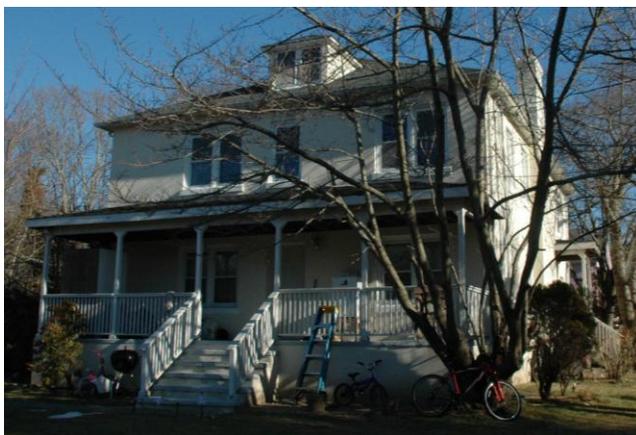
The foundation is poured concrete, the exterior building cladding appears to be stucco. There is a new roof, in good condition on the home. The Windows have been upgraded to vinyl frame units that also appear in good condition. Although not confirmed by this inspector, the perimeter above grade walls of the structure appear to be composed of solid masonry. Floor joists and subfloor are standard timber and plywood construction. Metal studs with sheetrock have been used to restore the interior spaces directly over the original interior finish in some cases.

There is no central air conditioning. Air conditioning is provided via window mounted air conditioning units. Heating is provided via an oil fired hot water baseboard system. There is a standalone dehumidifier in the basement.

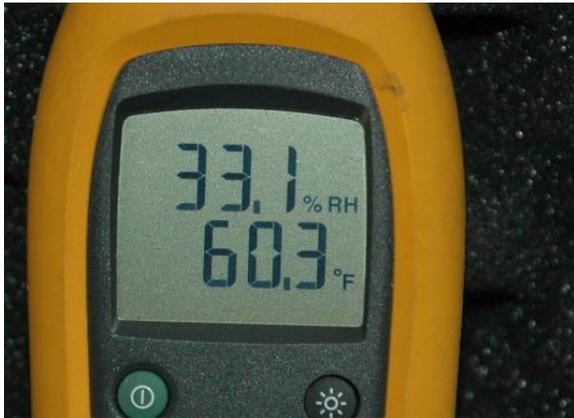
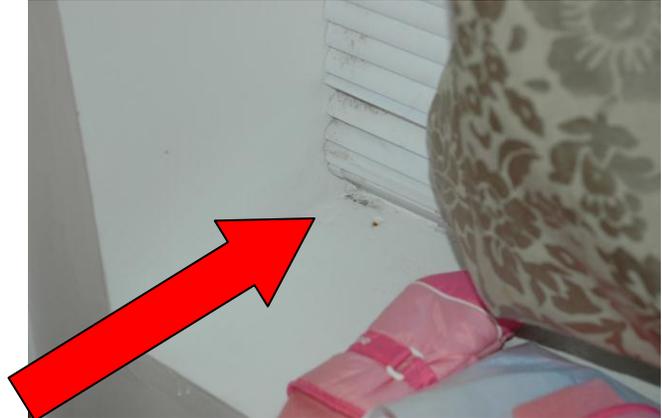
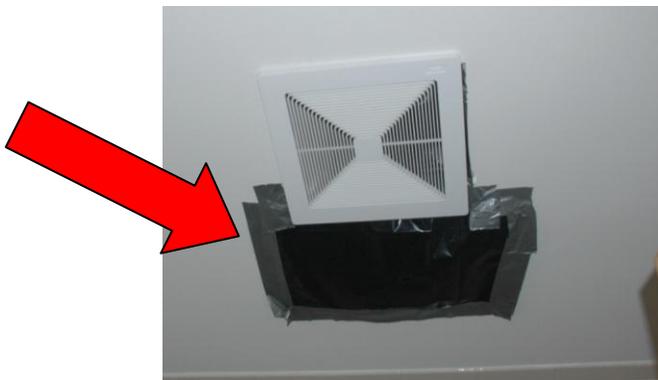
The apartment occupies the front half of the first floor of the building. The bedroom located in the front left corner of the home has some light staining on the exterior walls. There was no musty odor. The bathroom is located in the central portion of the building. There is an exhaust fan. The fan exhaust consists PVC pipe. This pipe is in excess of 25 feet and makes several turns as it courses through the building. Thermal imaging in the rear bedroom revealed a temperature anomaly consistent with a pipe leak which would be located below the baseboard radiator in the bathroom on the second floor.

In the **first floor front apartment bedroom** the amount of visible mold is less than 10 sq/ft and can be cleaned as follows:

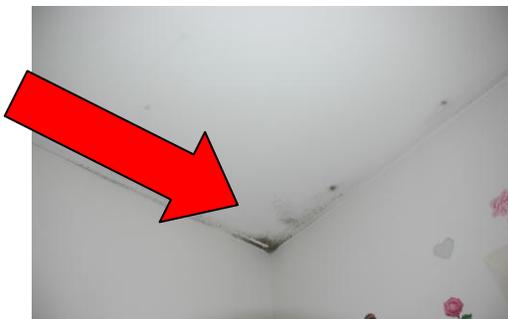
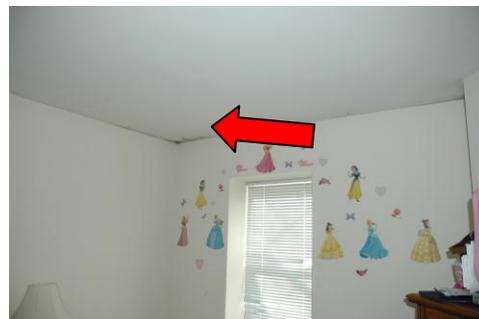
Significant staining is seen on the ceiling along the outer wall of the home, the right rear corner of the home. The total square footage of visible mold at the time of the inspection was less than 10 ft.<sup>2</sup> Two adults and one child use this bedroom sleeping. The pattern of mold growth is suggestive of thermal bridging. There is no bathroom exhaust fan. There is no kitchen exhaust fan.

In the **first floor rear apartment bedroom** the amount of visible mold is less than 10 sq/ft. yet we suspect that there may be hidden mold on the back side of the sheetrock given the pattern of growth and the rapid return of staining following the cleaning efforts to date. It should be cleaned as follows:

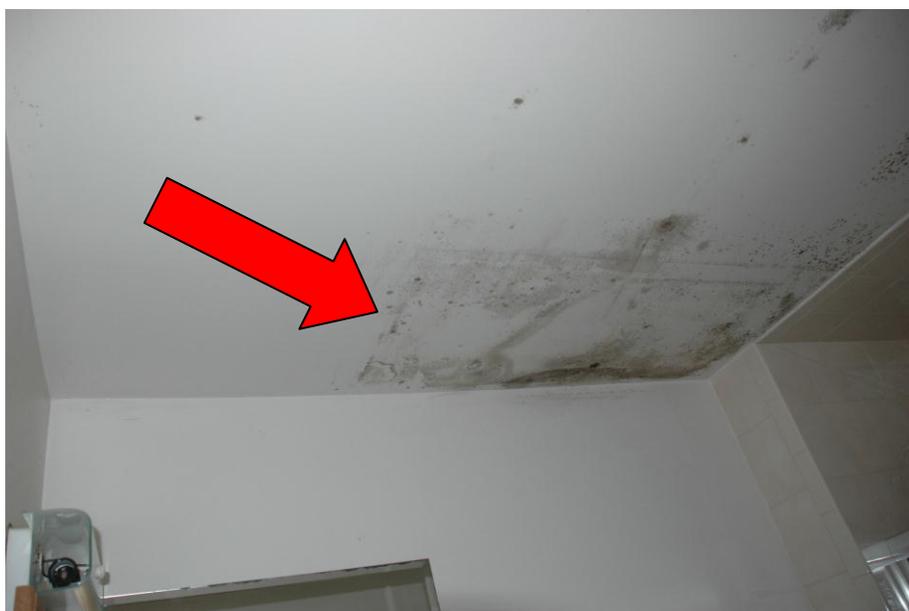
Significant mold growth and staining is seen on the **bathroom ceiling**. Total square footage of visible mold is in excess of 30 ft.<sup>2</sup> but less than 100 ft.<sup>2</sup> There is no bathroom exhaust fan. Mold growth is seen behind the baseboard in the bathroom as well as behind the slant fin cover. There appears to be a leak from the baseboard heat in his location.

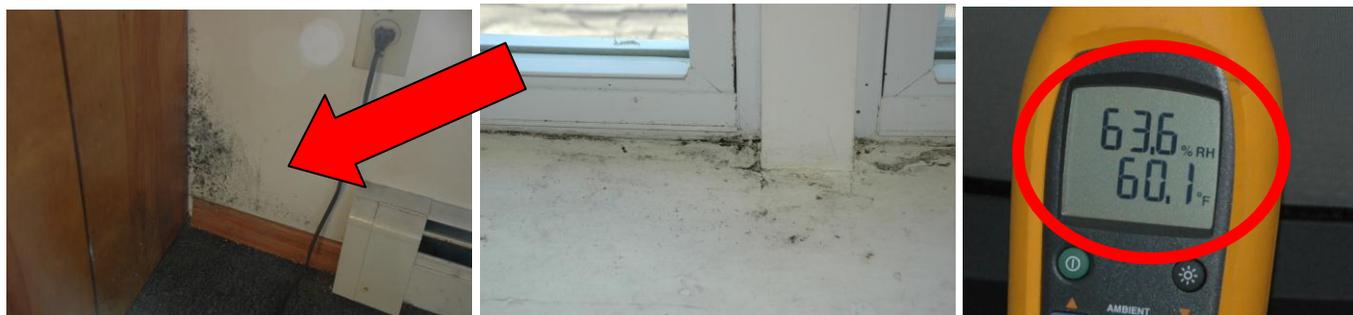
Visible mold growth was seen in the front bedroom along the window extension jams and at the base of the closet door. Large amounts of condensation were noted on the interior of the windows. Total square footage of visible mold in his bedroom is between 10 and 100 ft.<sup>2</sup>

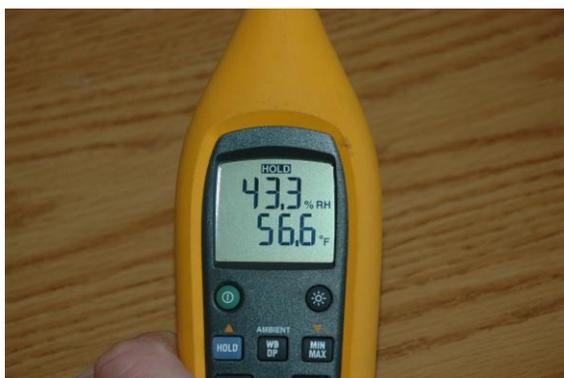
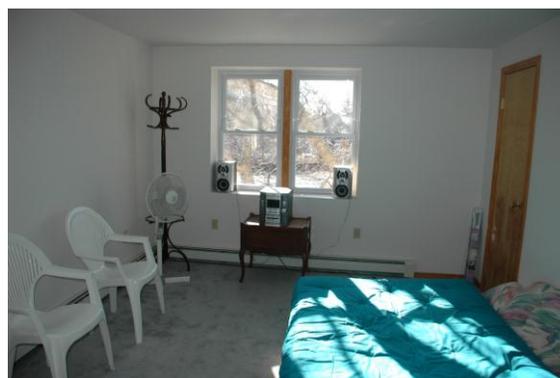
This apartment is furnished and carpeted but unoccupied. There is no visible mold growth or odor consistent with microbial VOC's. There is no bathroom exhaust fan. There is no kitchen.

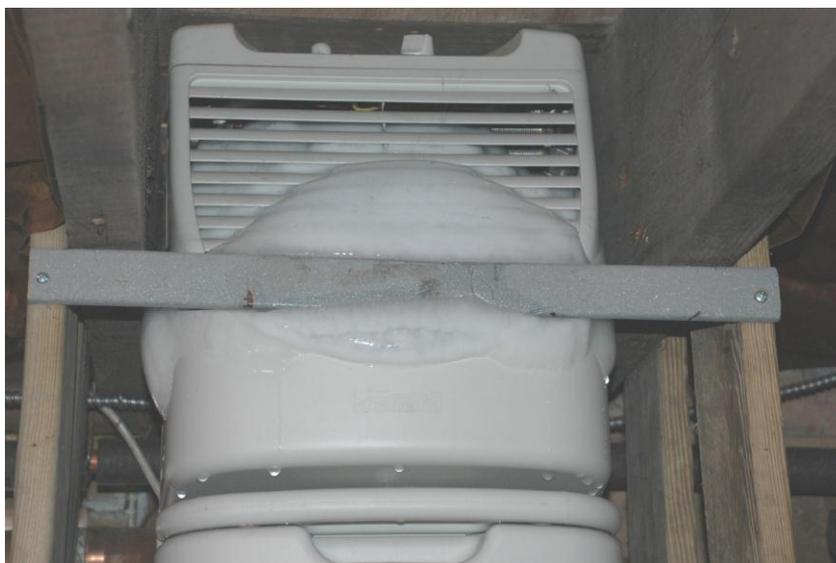
Efflorescence is noted on some of the exterior foundation walls. This is suggestive of water intrusion. There is a standalone dehumidifier for the rear portion of the basement. The unit was iced up and frozen at the time of the inspection. There was no visible mold in the basement or odors suggestive of active mold growth, VOC's.

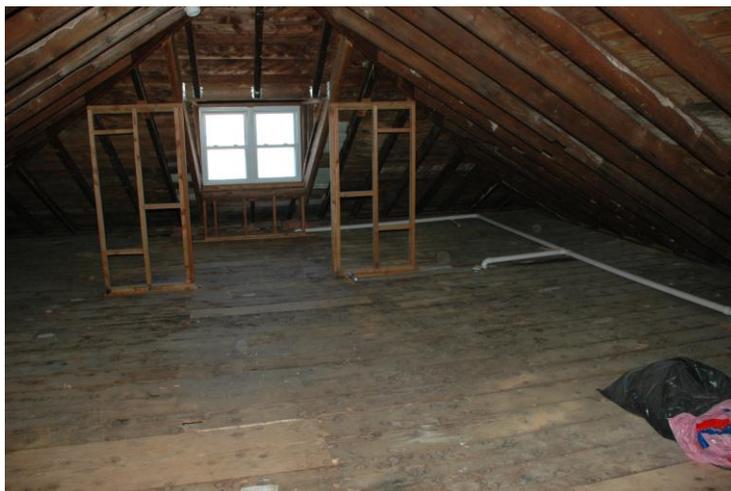
The attic space is empty, unfinished. Access is via a hallway hatch. There is mild mold growth noted on the under surface of the wood particularly at the lower portions of the sheathing where the sheathing is closest to the eaves. The attic is well ventilated at this time.

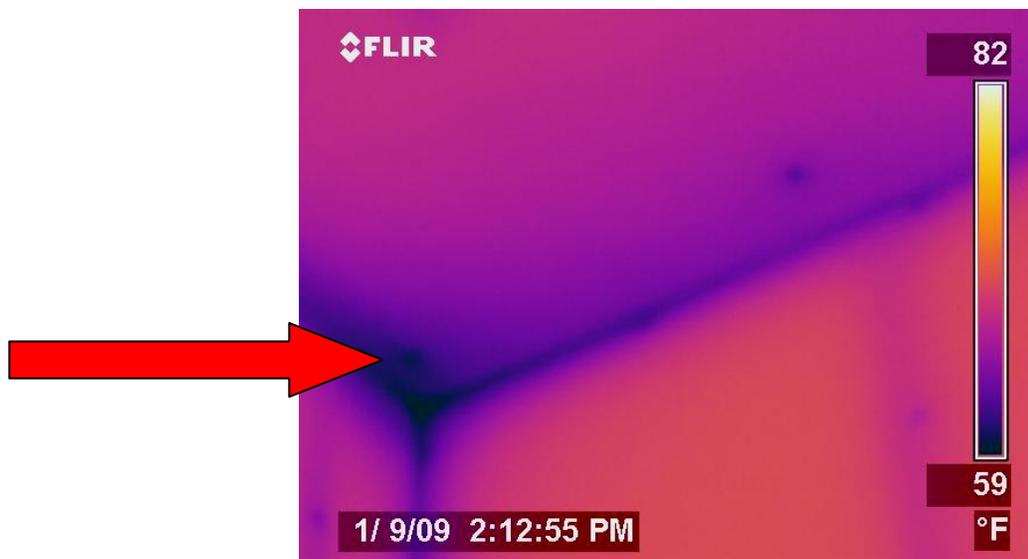
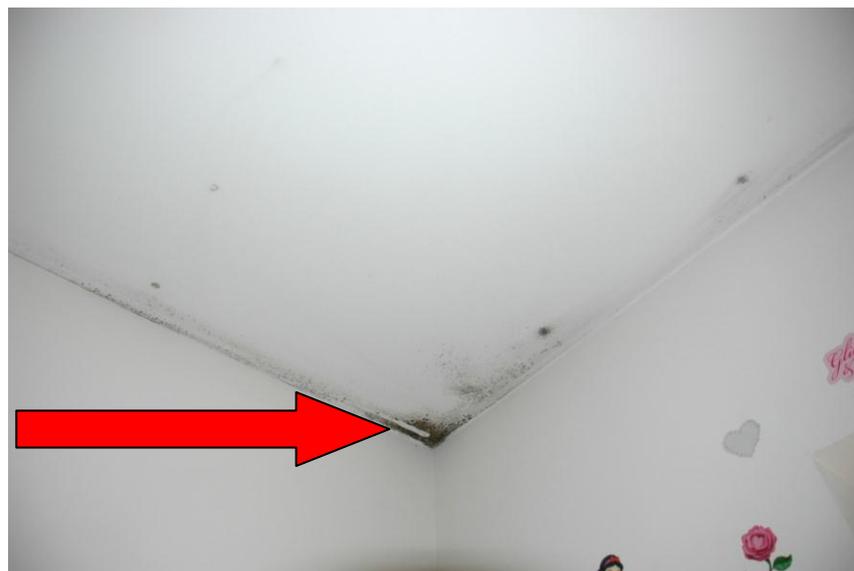
We utilized a FLIR infra red camera during the inspection. The below thermal images show a pattern of thermal bridging in the building with mold growth on the cooler surfaces. **Just like a cold drink will bead up and sweat during the summer months, the humid air in the various rooms from the occupants breathing, cooking, and bathing is condensing on the coldest portions of the building.**

**Efforts to improve the ventilation in the building such that the occupant generated humidity is not allowed to rise and remain above 55%.**

This should include installing humidistatically controlled exhaust fans in ***both*** the bathrooms and the bedrooms. These fans should be ducted to vent directly to the exterior of the home with the shortest and straightest vents possible. We further recommend that you install kitchen exhaust fans that vent to the exterior of the building.
