SUMMARY OF OUR FINDINGS

INFRARED INSPECTION REPORT

[REDACTED]
Southampton, NY

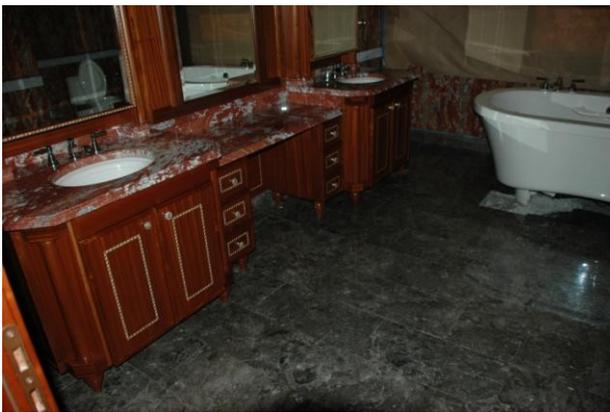
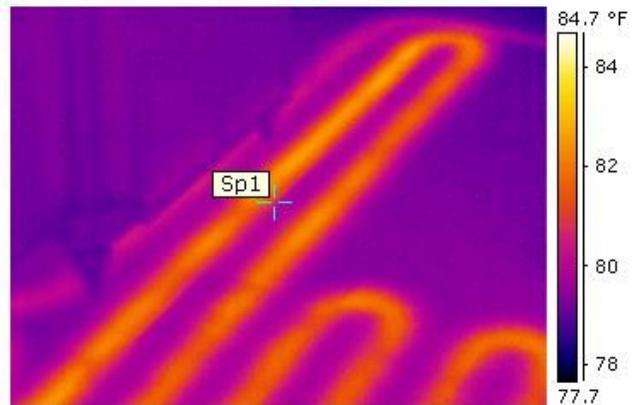
The pattern of the tubing appeared neat and professional. There were no kinks or overlapping sections of tubing.

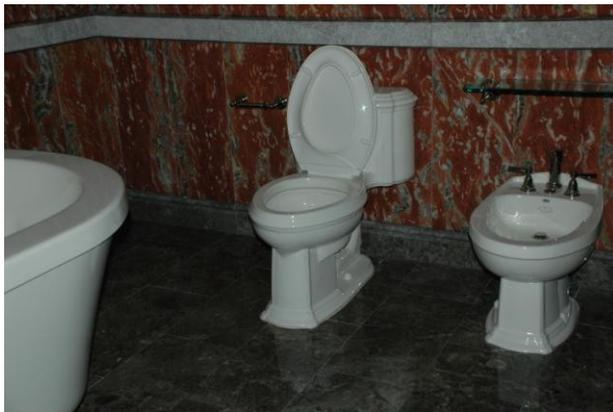
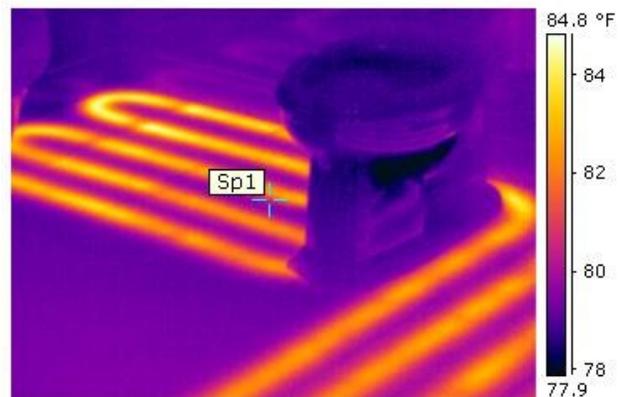
There was no evidence of leaking from the radiant floor heating under the toilet or bidet.

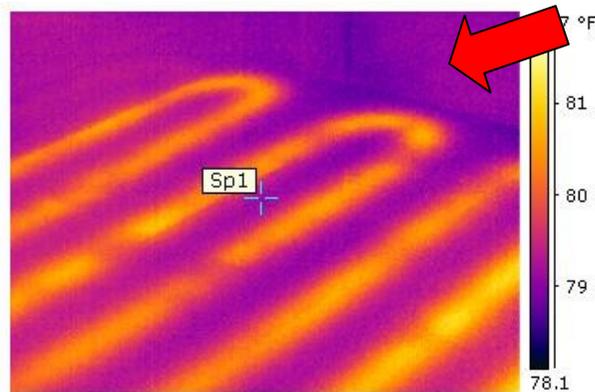
There was no evidence of failure of the radiant floor heating either side of the entry doorway to the master bathroom. The image below shows the radiant floor heating just in front of the entry doorway to the master bathroom. The entry doorway as indicated by the red arrow.

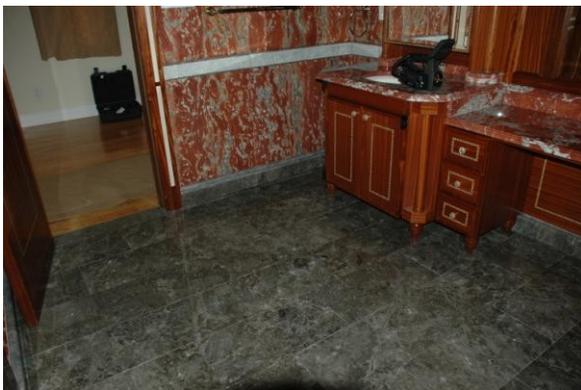
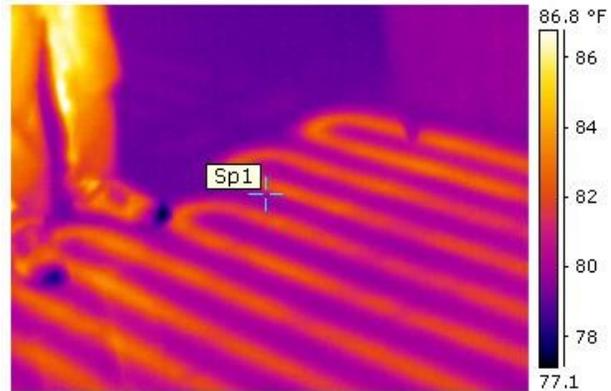
This set of images below show the radiant floor heating to the right and underneath the sink vanity. Again, we find no evidence of leaking.

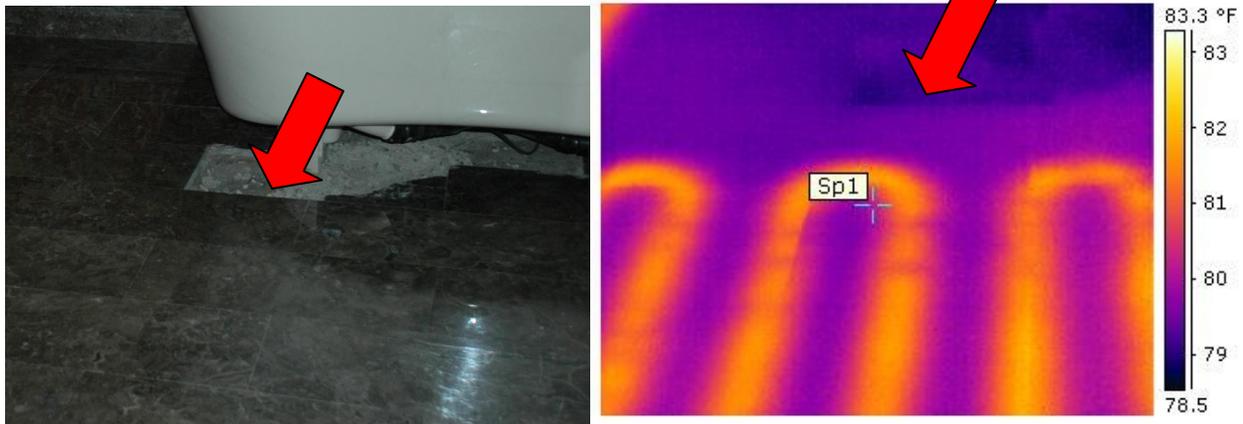
The images below show the radiant floor heating near the bathtub. A section of tile had been removed from the floor. For reference this section of floor was indicated by the red arrow. There is no radiant floor heating underneath the bathtub. There is no indication that the loops over a floor heating or leaking near this section of floor where the tile was removed.

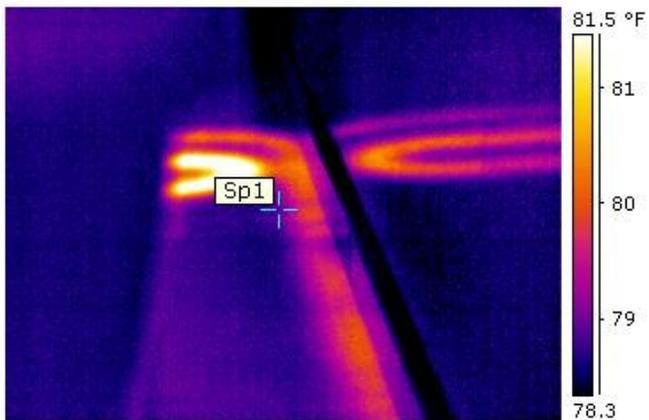
The thermal image below shows a return loop along the exterior wall behind the bathtub. There is no indication at this return loop is leaking.

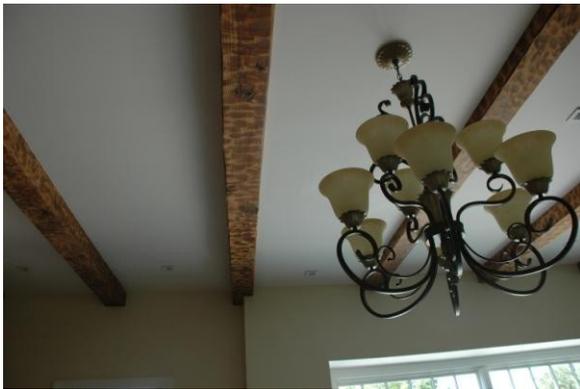
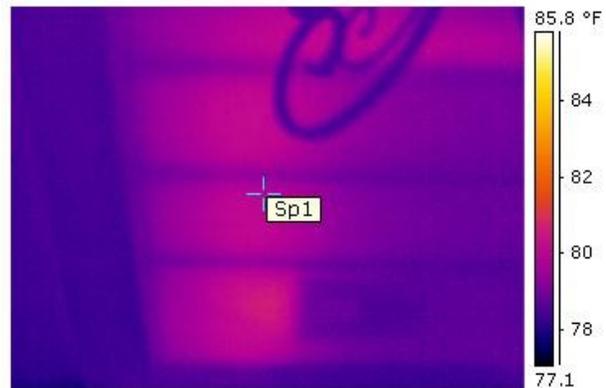
The images below were obtained in the living room below the master bathroom. We do not find any indication that water is pooling or collecting above the drywall ceiling. We can see that the choice they were the radiant tube's are located does as one would expect.

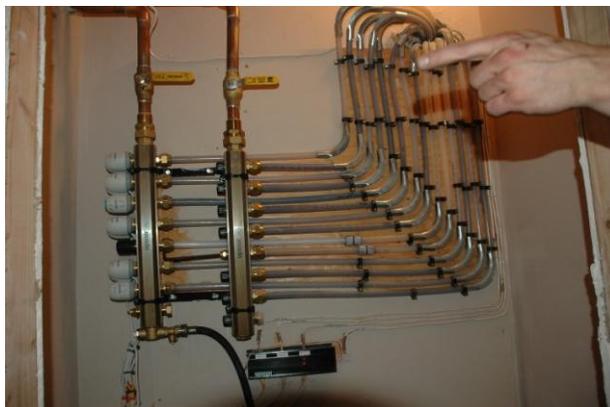
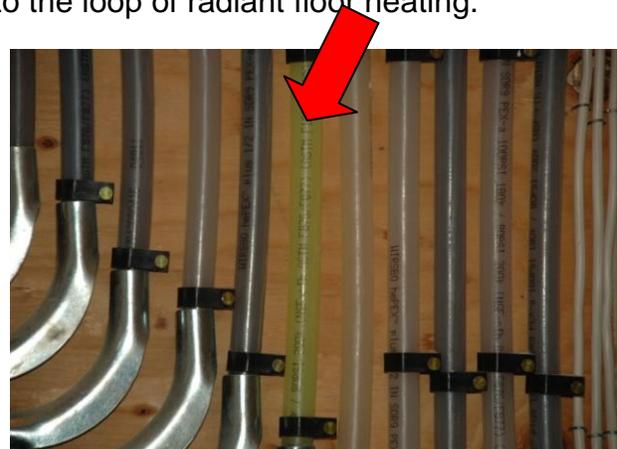
The images below show the radiant floor heating manifold in the basement. The installation is clean and professional. Our testing of the ratings were eating included operating system above normal temperatures and above normal operating pressures up to 150 psi. At no point during our test cycles was there an indication that the loop of radiant floor heating was leaking. The radiant floor heating system maintained constant pressure. There was no visible moisture in the master bathroom or living room ceiling. We capped the loop of radiant floor heating for one hour and the system maintained a constant pressure.

Following these multiple tests and thermal imaging of the master bathroom loop of the radiant floor heating yellow fluorescene dye was introduced into the loop of radiant floor heating.

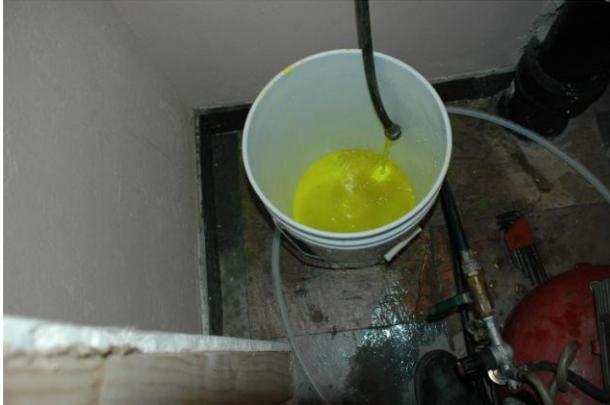
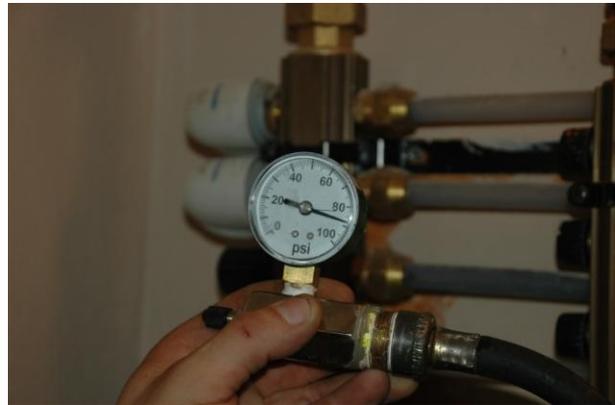
The yellow dye was circulated through the radiant floor heating until the return line demonstrated

complete fill. This can be seen by the yellow dye filling the bucket below. The system was brought back under pressure and sealed at 90 PSI.

We recommend you return to the home in several days to reject the pressure. If there is any yellow dye noted in the master bathroom floor or living room ceiling above it only would've come from the radiant floor heating loop. If there is moisture in those areas, but it is not yellow, It is not from the radiant floor heating.
