PROFESSIONAL BUILDING INSPECTORS

WATER INTRUSION TEST AND INFRARED INSPECTION

Inspection address: New Rochelle, NY 10804

Date of Inspection: June 2008

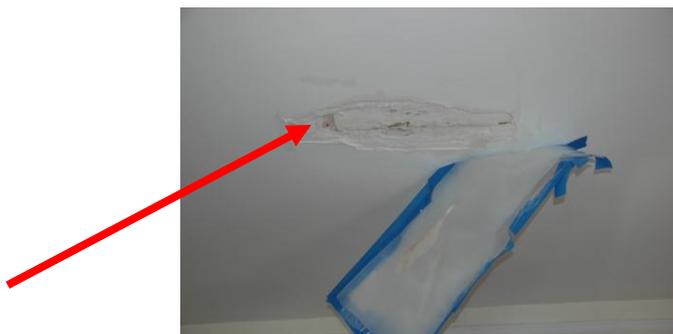
At the onset of the inspection we documented visibly deteriorated plaster on the ceiling in the living room of unit XX. The impacted area appeared to measure approximately 1'x3' and is shown below.

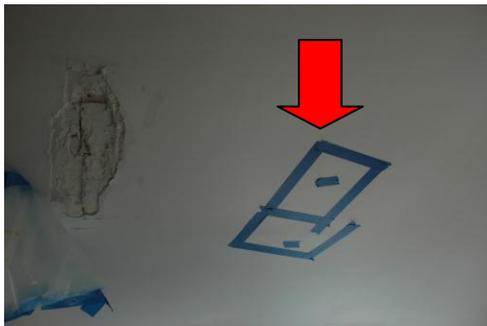
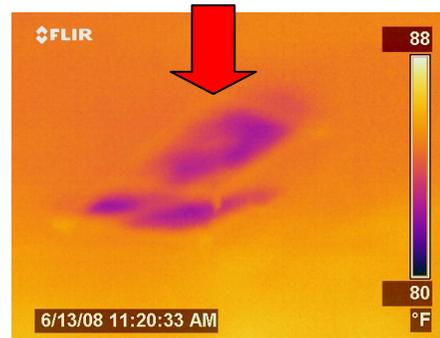
A baseline thermal imaging of the ceiling *revealed moisture not previously identified*. These areas were marked with 3M blue painters tape as detailed below with the thermal image.

Moisture reading taken at the center of these thermal anomalies revealed markedly moisture content of the plaster. The readings in this area of interest ranged from 9% to 14%. Normal reading would be less than 0.5% per ASTM standards.

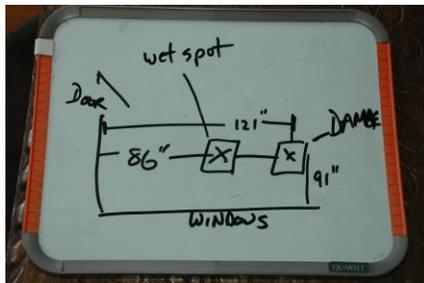
Using the same fixed building landmarks as a reference the terrace on the ■ floor above was visually inspected. The furniture in this area was carefully removed.

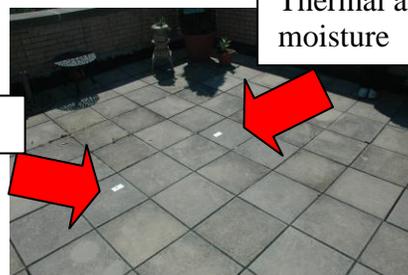
Visible damage

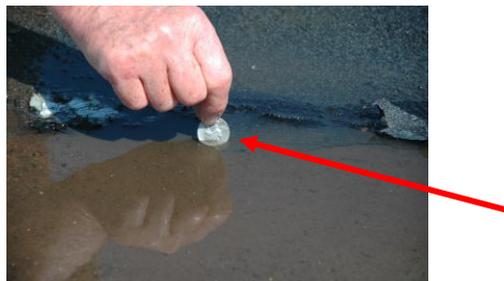
Upon removal of the concrete patio flags in this area we identified an EPDM type roofing membrane. Above this there is foam insulation and Kraft paper. Care was taken in peeling back the Kraft paper and lifting the foam insulation so as to not cause any further damage.

At this point we noted ponding water atop the EPDM membrane measuring 3/8" in depth.

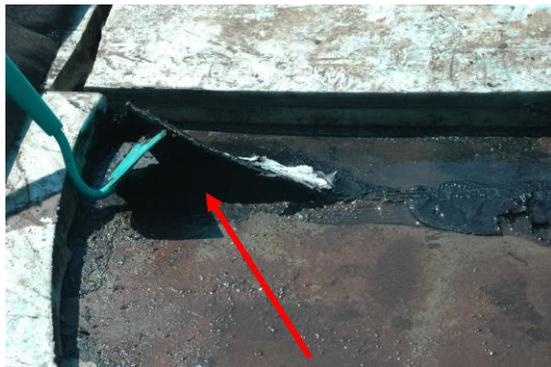
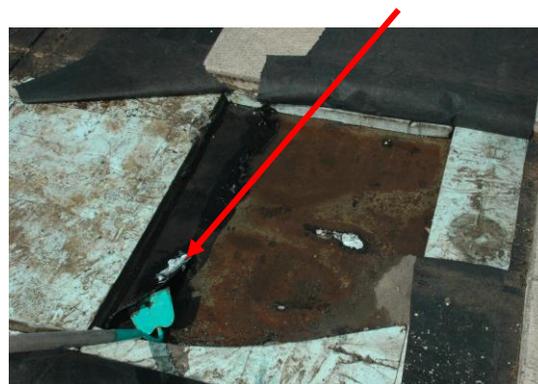
In addition to the standing water under the foam insulation we identified a roof patch. This patch is located directly above the thermal anomaly and ceiling moisture in unit [REDACTED]. The roof patch material appeared to be Asphalt based. It has been well documented that **EPDM membranes and Asphalt roofing are not compatible materials, and if used together the Asphalt will chemically eat through the EPDM membrane.**

The failed roof patch, shown in more detail below, is non-adherent to the EPDM at this point.

In our professional opinion, based on the testing performed, there are two problems that need to be addressed. In the short term the roof leak identified can be readily repaired using compatible materials. This will not however address the underlying concerns we have regarding these roof systems.

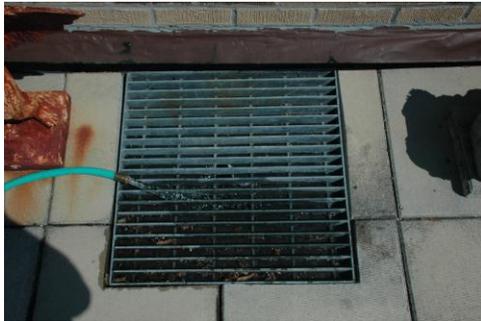
Water was initially discharged directly into the roof drain, pictured below. This was done for 15 minutes, at 5 gallons per minute, to confirm that the roof drain was functional and not backing up onto the roof.

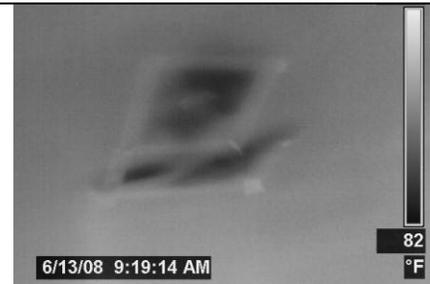
No changes from baseline are seen in this black and white Thermogram

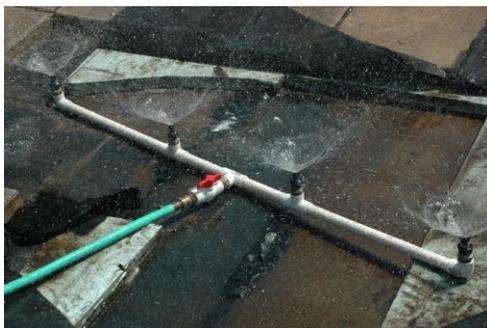
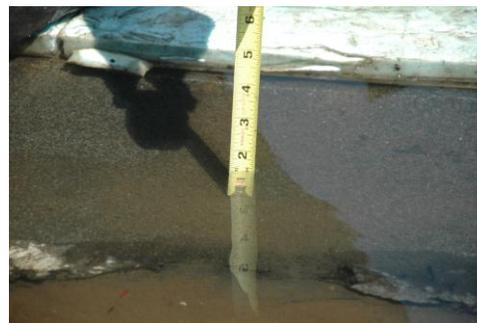
At the conclusion of this test we noted that the standing water on the roof had increase to 1.5" in depth with no water seen at the roof drain, indicating the is not sufficiently pitched towards the roof drain.

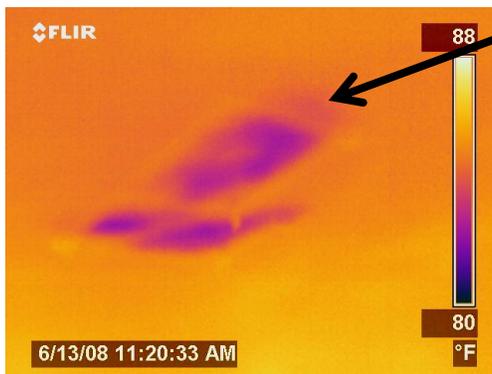
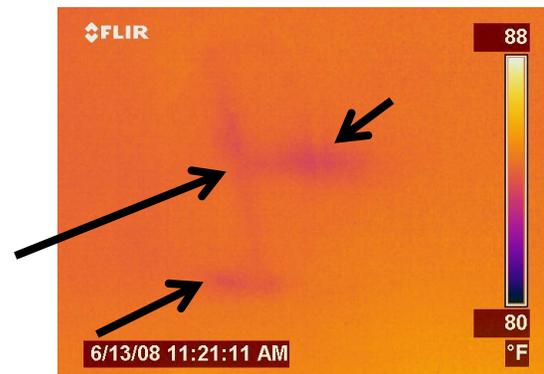
Thermal imaging and moisture testing in unit ■ found an increase in the size of the thermal anomaly and moisture content of the plaster ceiling consistent with the leak being actively

generated.

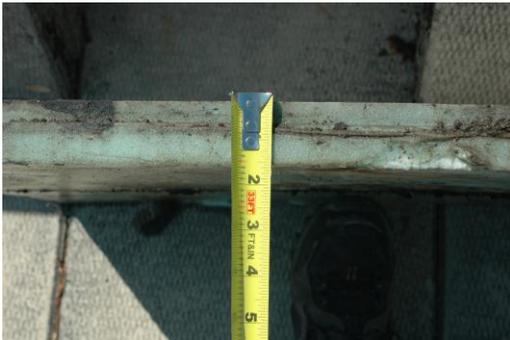
Reference image of the foam insulation detailing the *lack* of a tapered edge to facilitate drainage.

- load since the roof is being used as an entertainment area. An additional benefit will be to reduce the load on the support timbers by removing any remaining terra cotta roof tiles
2. The exposed roof rafters need to be examined where they rest in the masonry walls, and any decayed (dryrot) damaged rafters need to be sister beamed to restore the structural integrity of the roof.
 3. Once the above is completed a new plywood or "Q" deck should be installed, over which rigid foam sheets tapered in the factory or at time of installation should be installed to create positive drainage pitch to the existing roof drains.
 4. Over the rigid foam sheets a new 30 year Firestone EPDM roof system and flashing should be installed.
 5. Once the EPDM roof has been installed EPDM roof pads designed to facilitate drainage shall be installed and then the existing roof tiles can be re-installed.
